# What's In That Tube 2?

(Sequel to What's In That Tube ?)

Hawaii Water Environment Association Conference

March 15, 2010

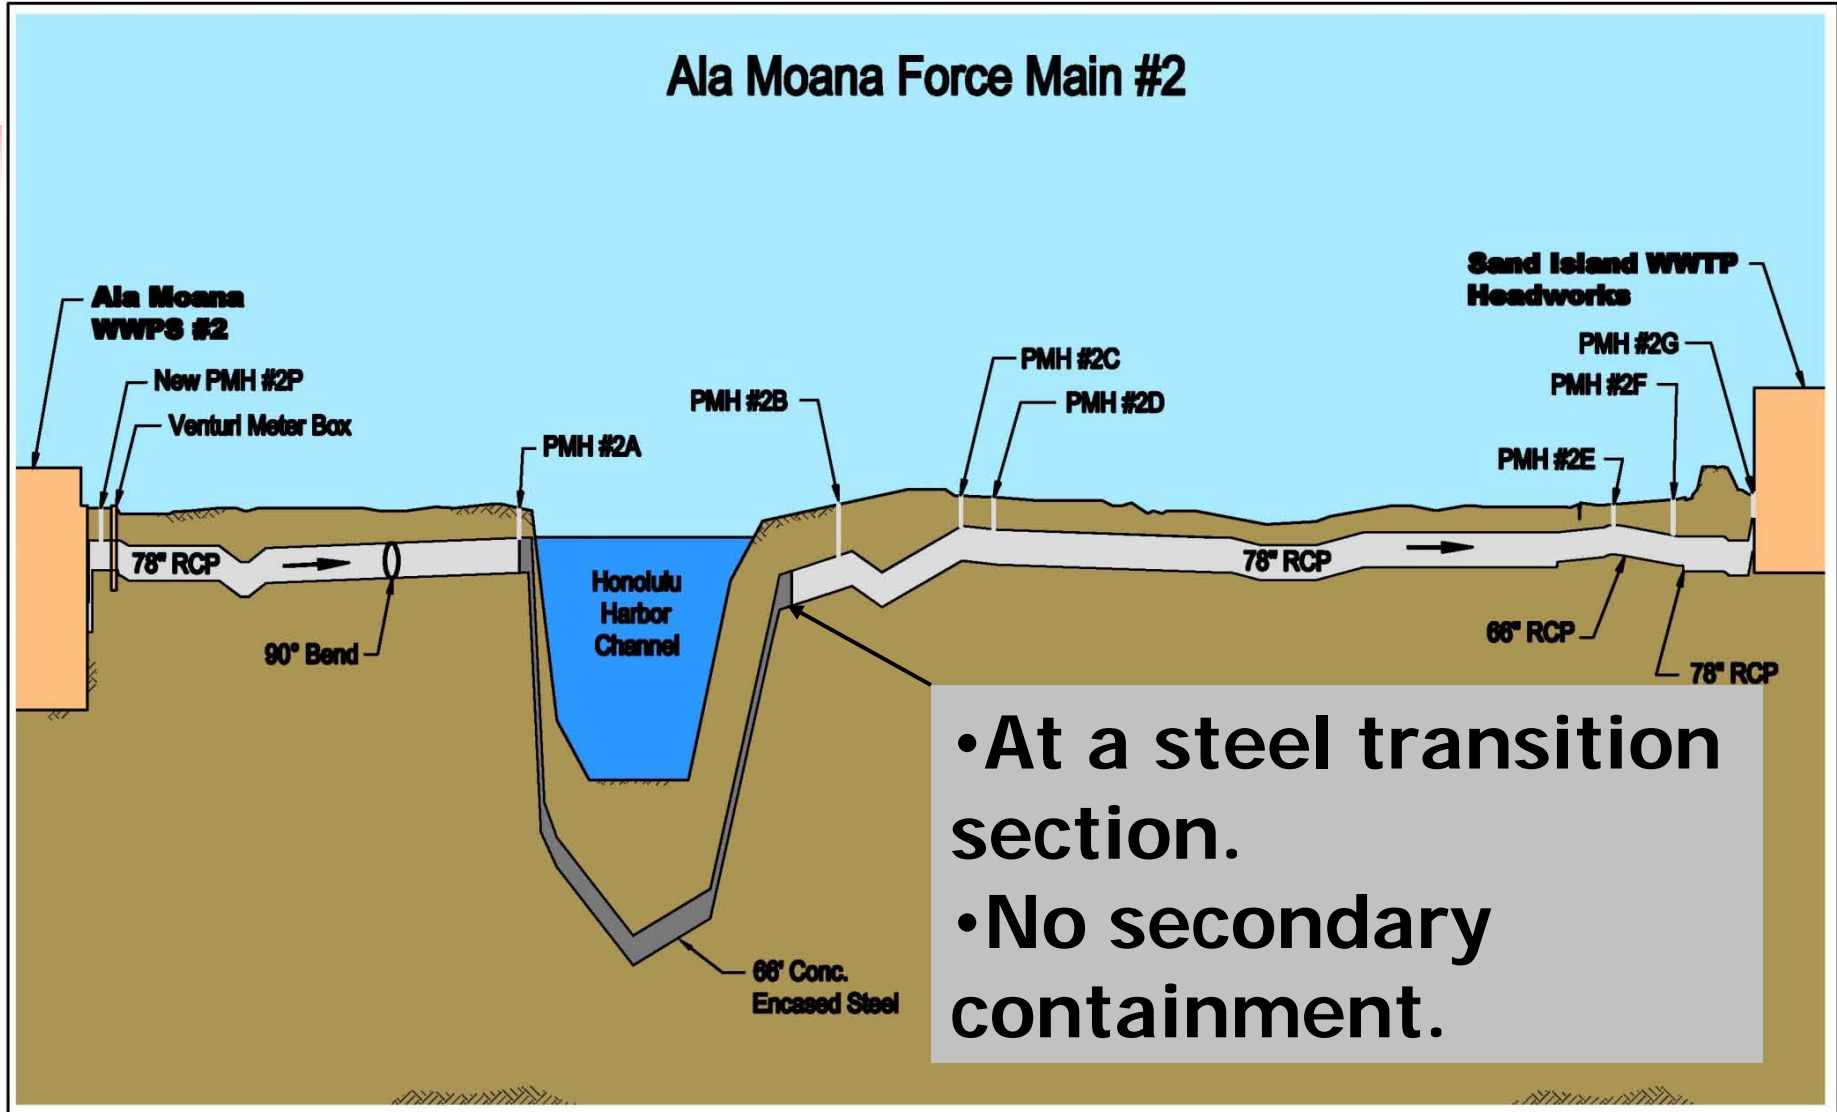
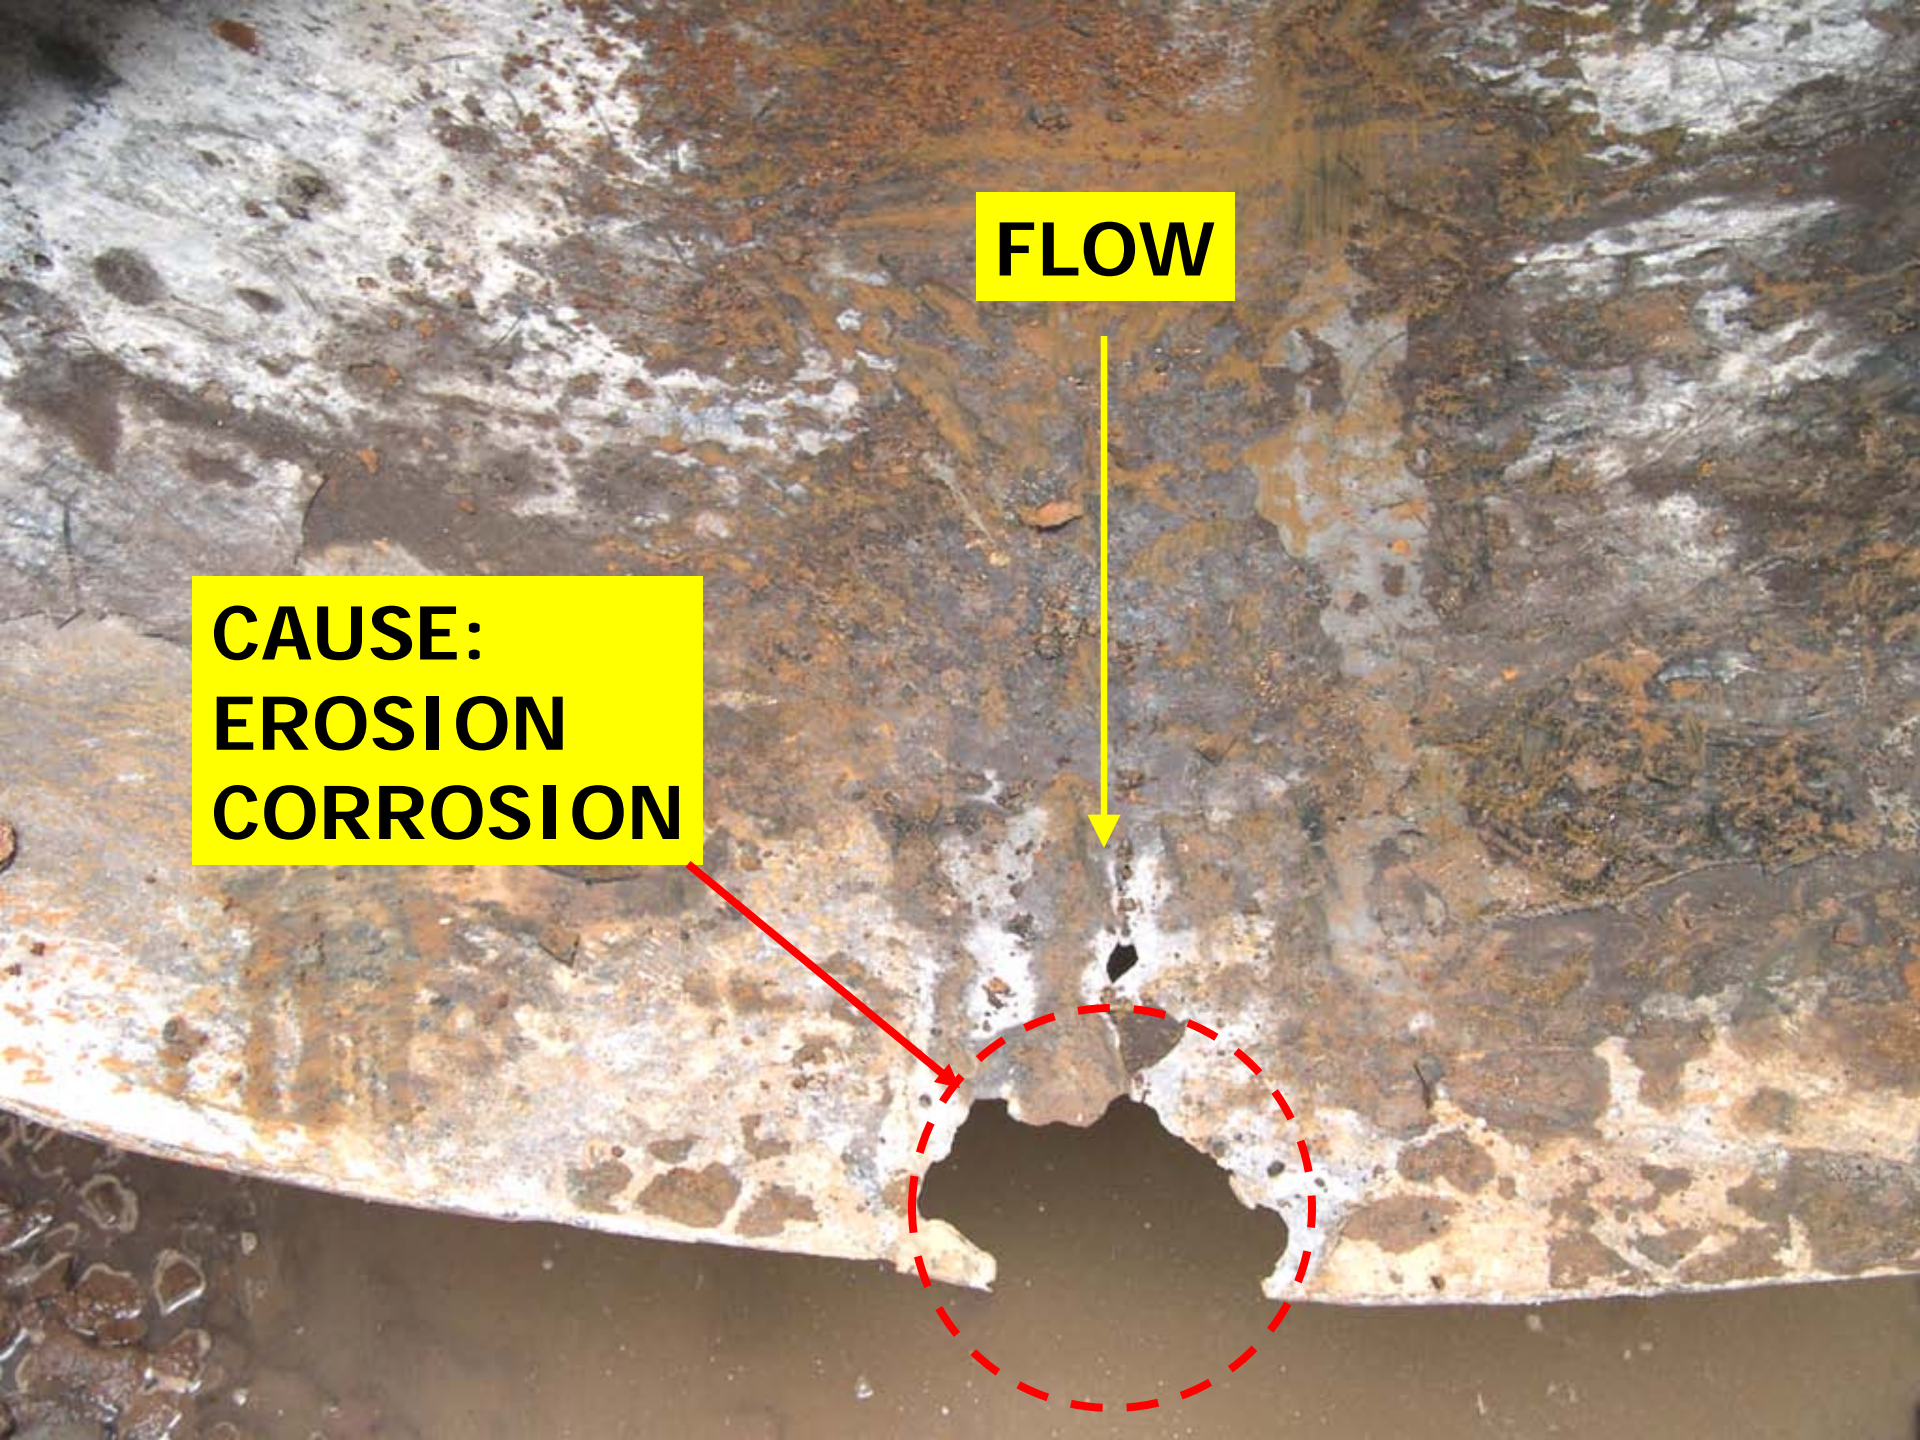
# THE ALA MOANA FM#2 BREAK OF 2004

**FLOW**

**CAUSE:  
EROSION  
CORROSION**

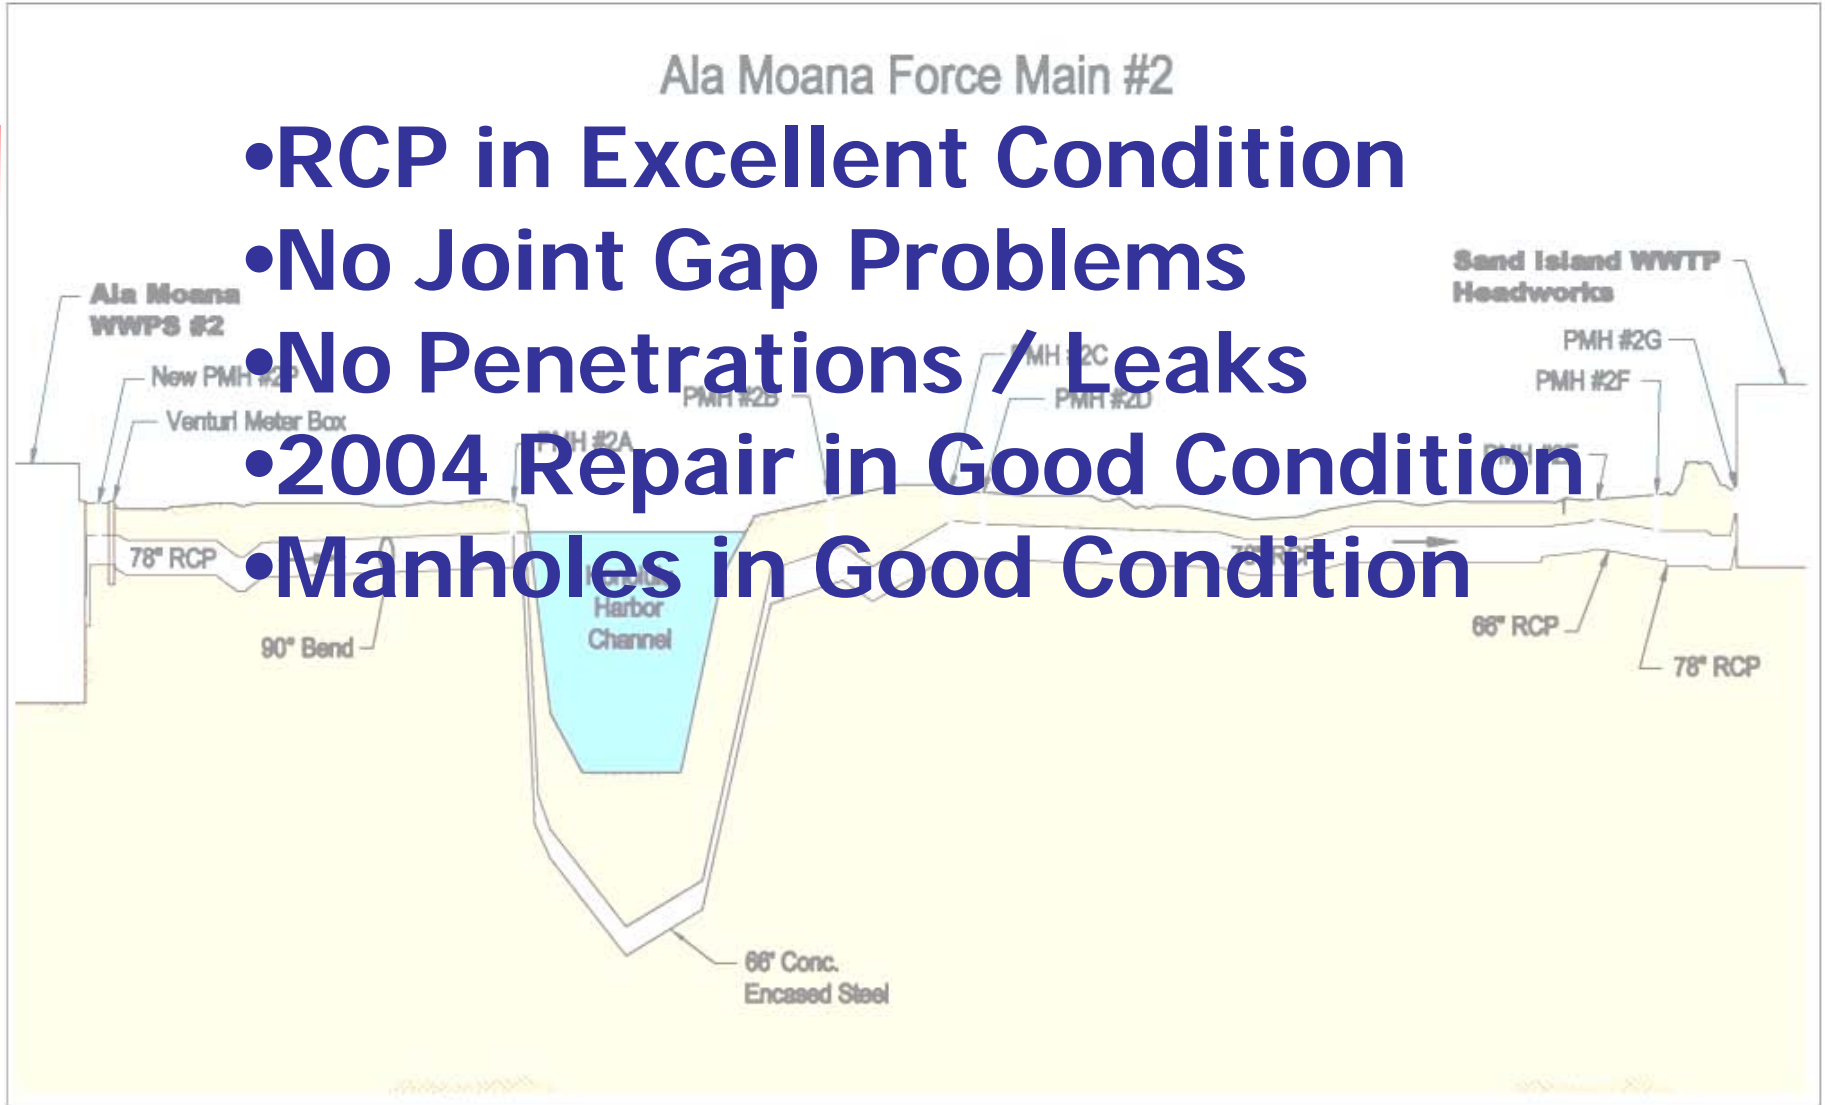
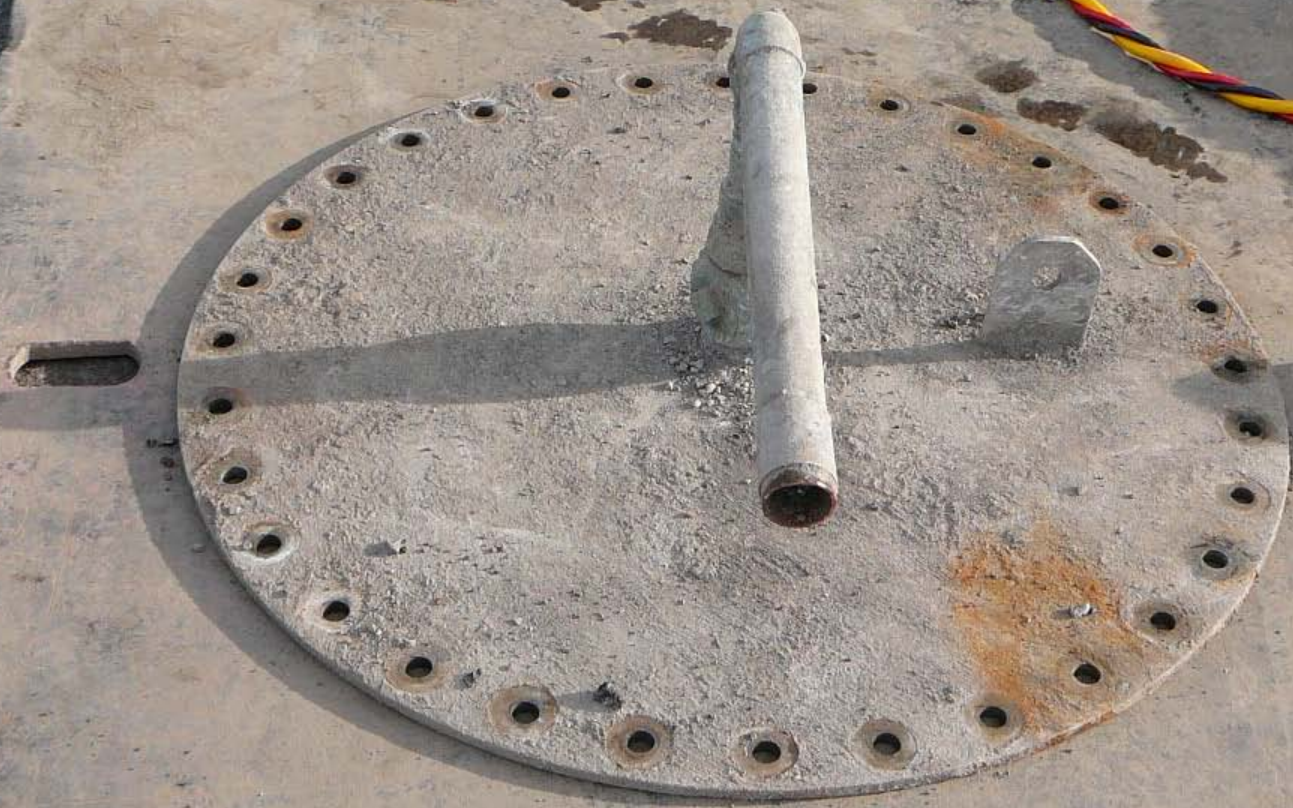
# RESULTS: THE GOOD

- RCP in Excellent Condition
- No Joint Gap Problems
- No Penetrations / Leaks
- 2004 Repair in Good Condition
- Manholes in Good Condition

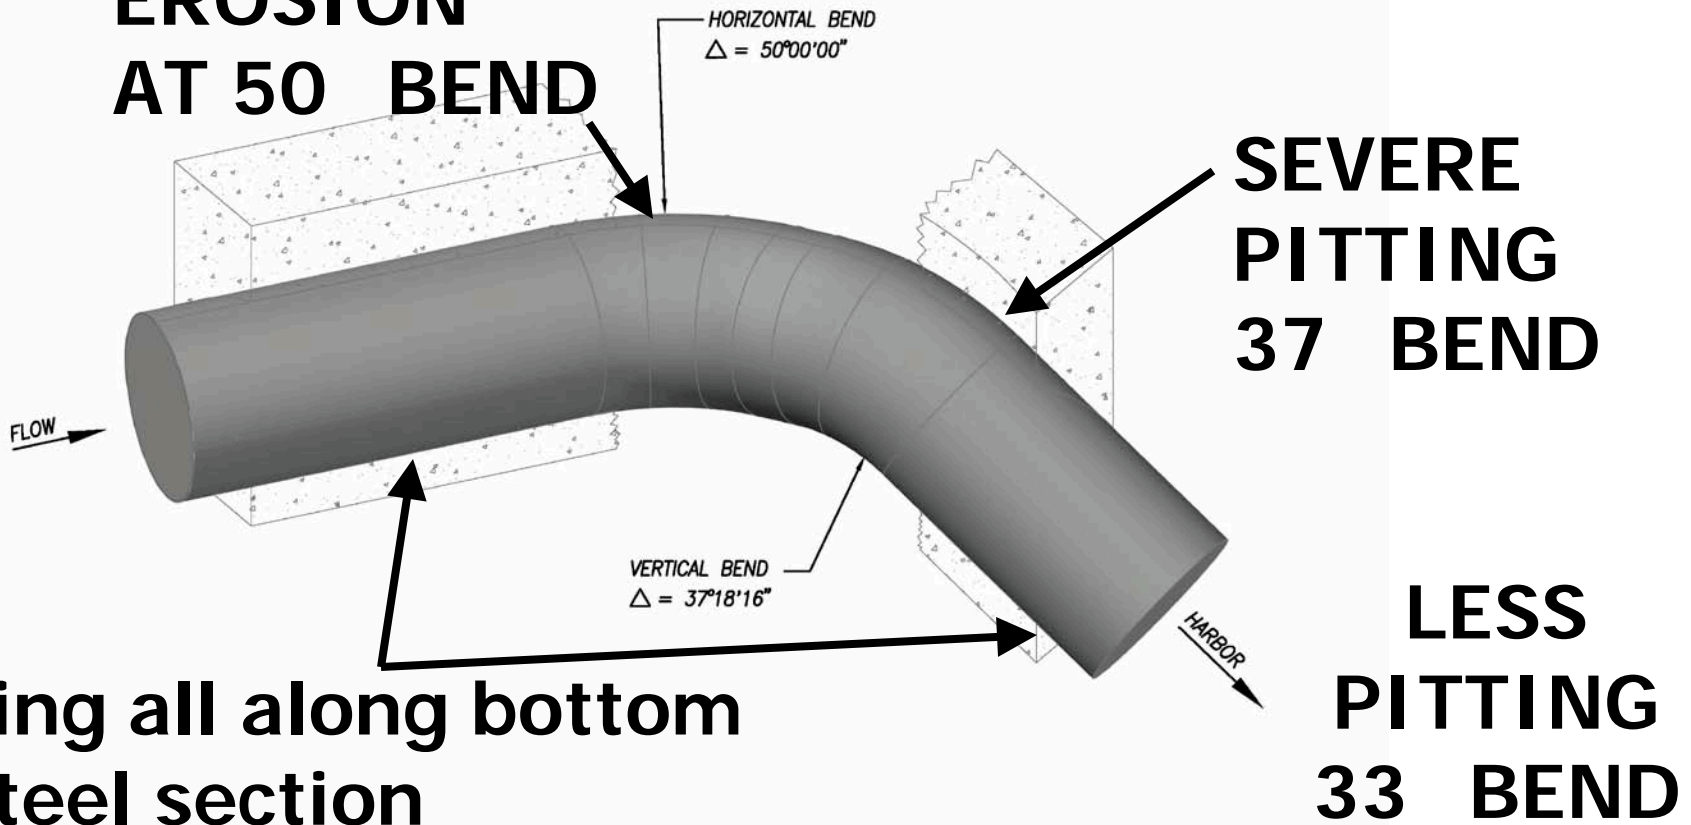
# The Achilles Heel

**WORST  
EROSION  
AT 50 BEND**

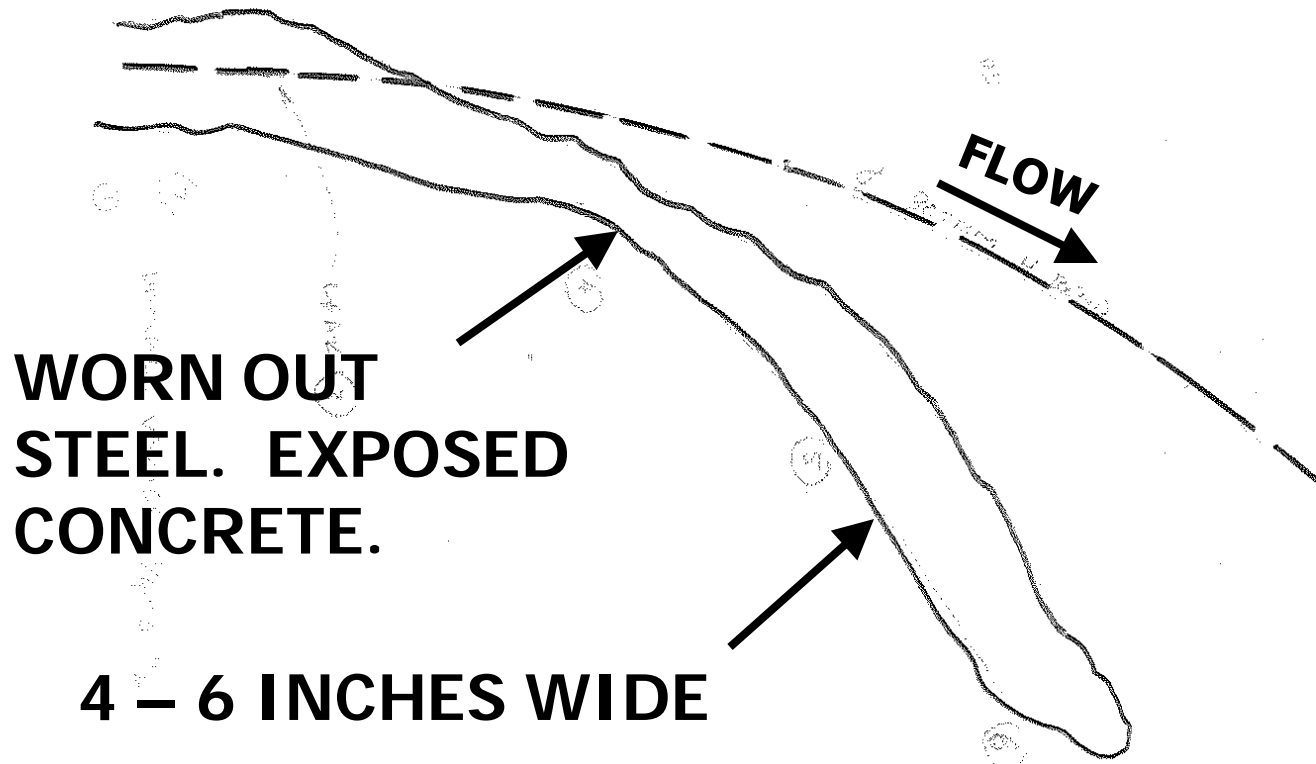
# Condition Of 50 Bend

**WORN OUT  
STEEL. EXPOSED  
CONCRETE.**

**4 - 6 INCHES WIDE**

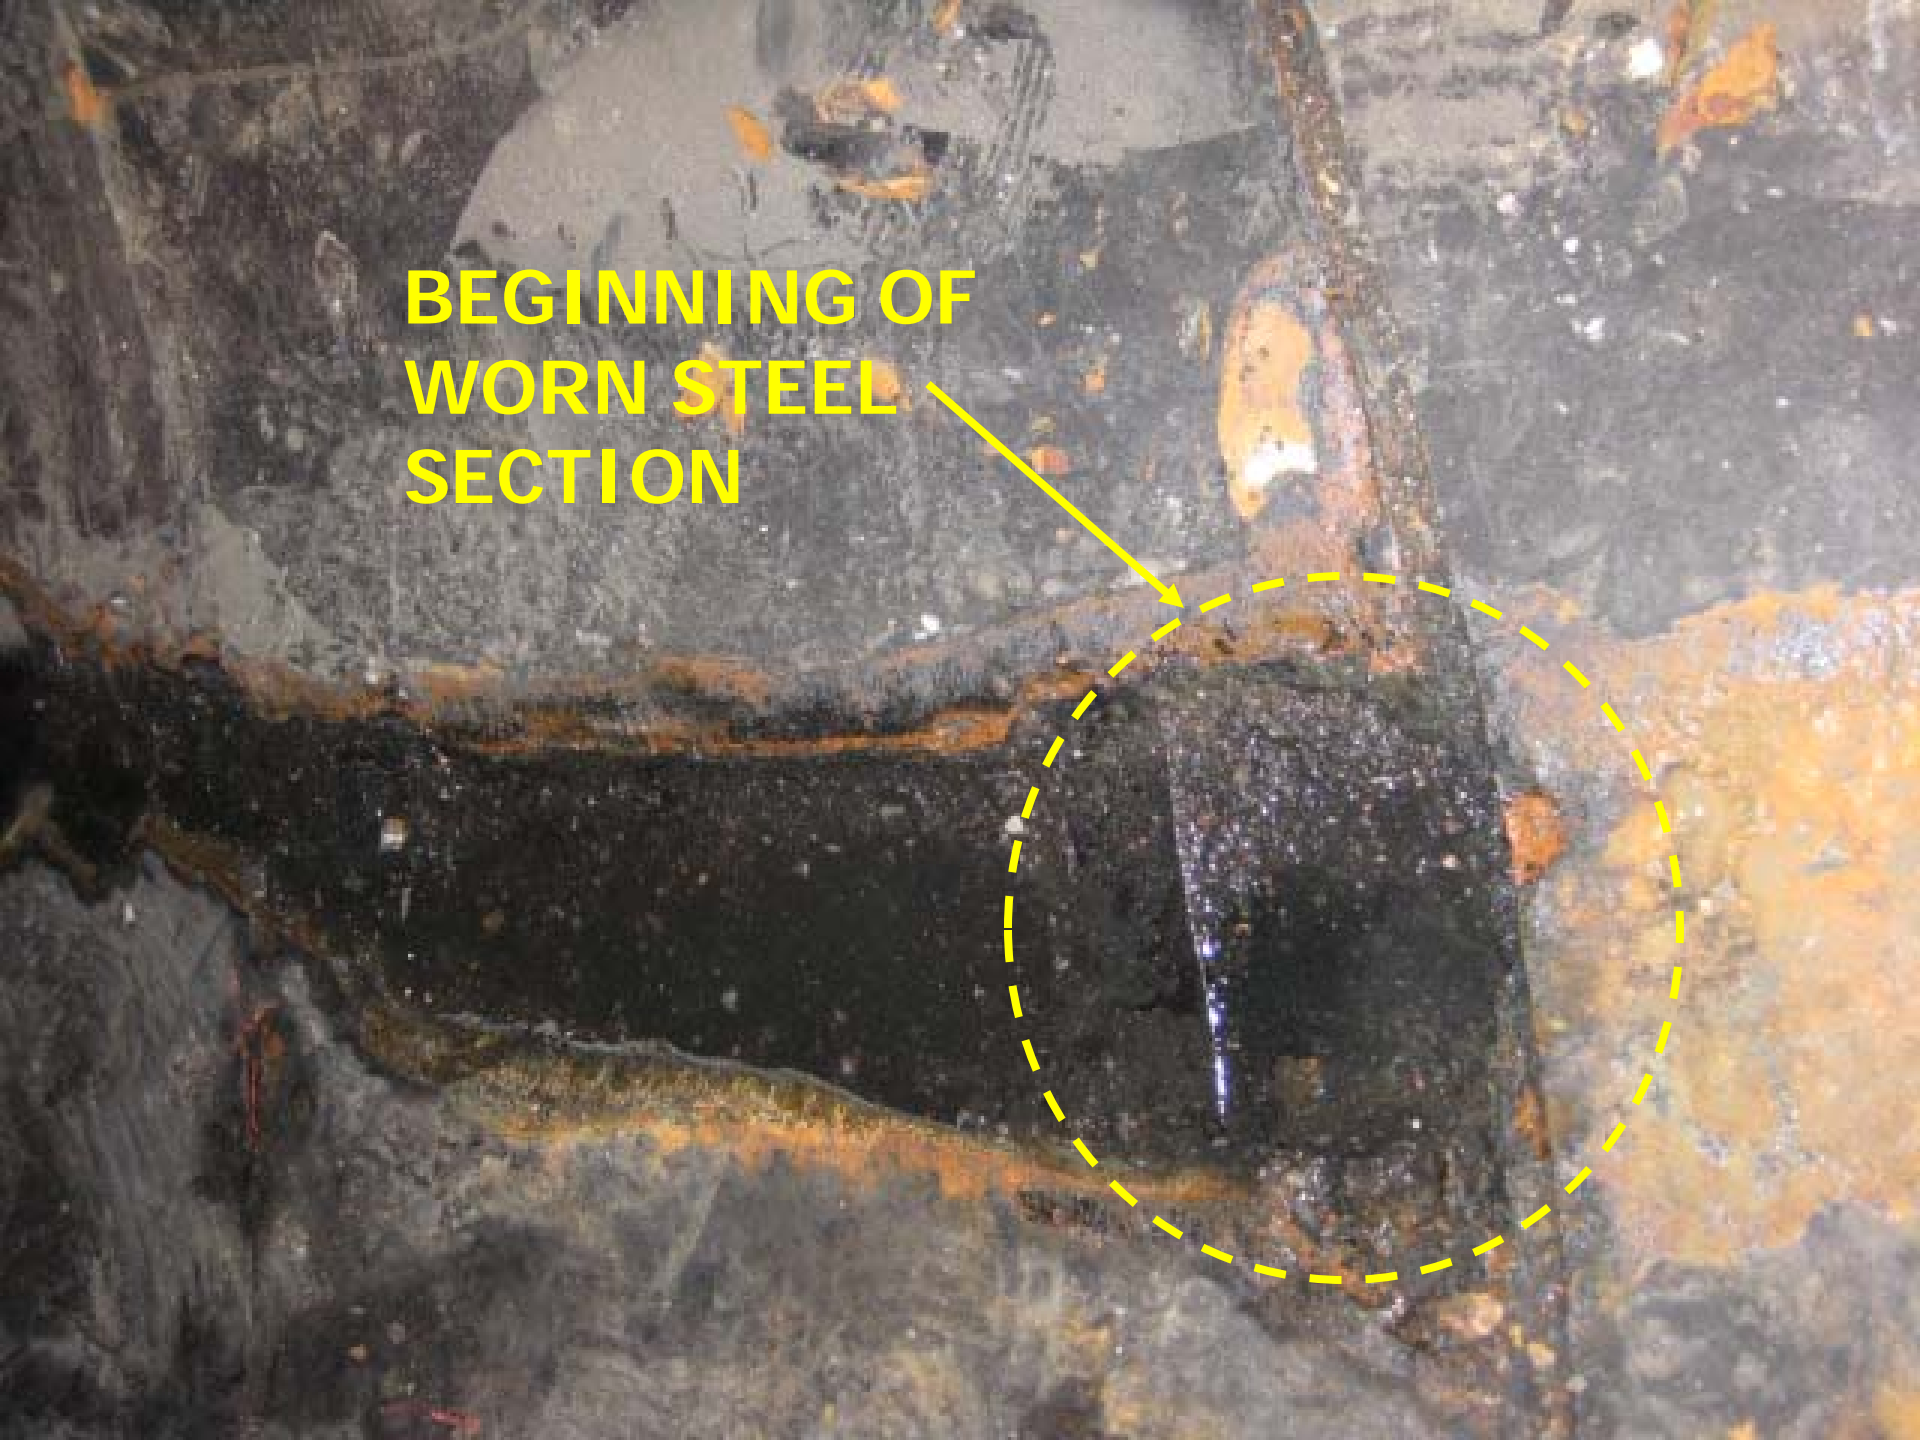
**BEGINNING OF  
WORN STEEL  
SECTION**

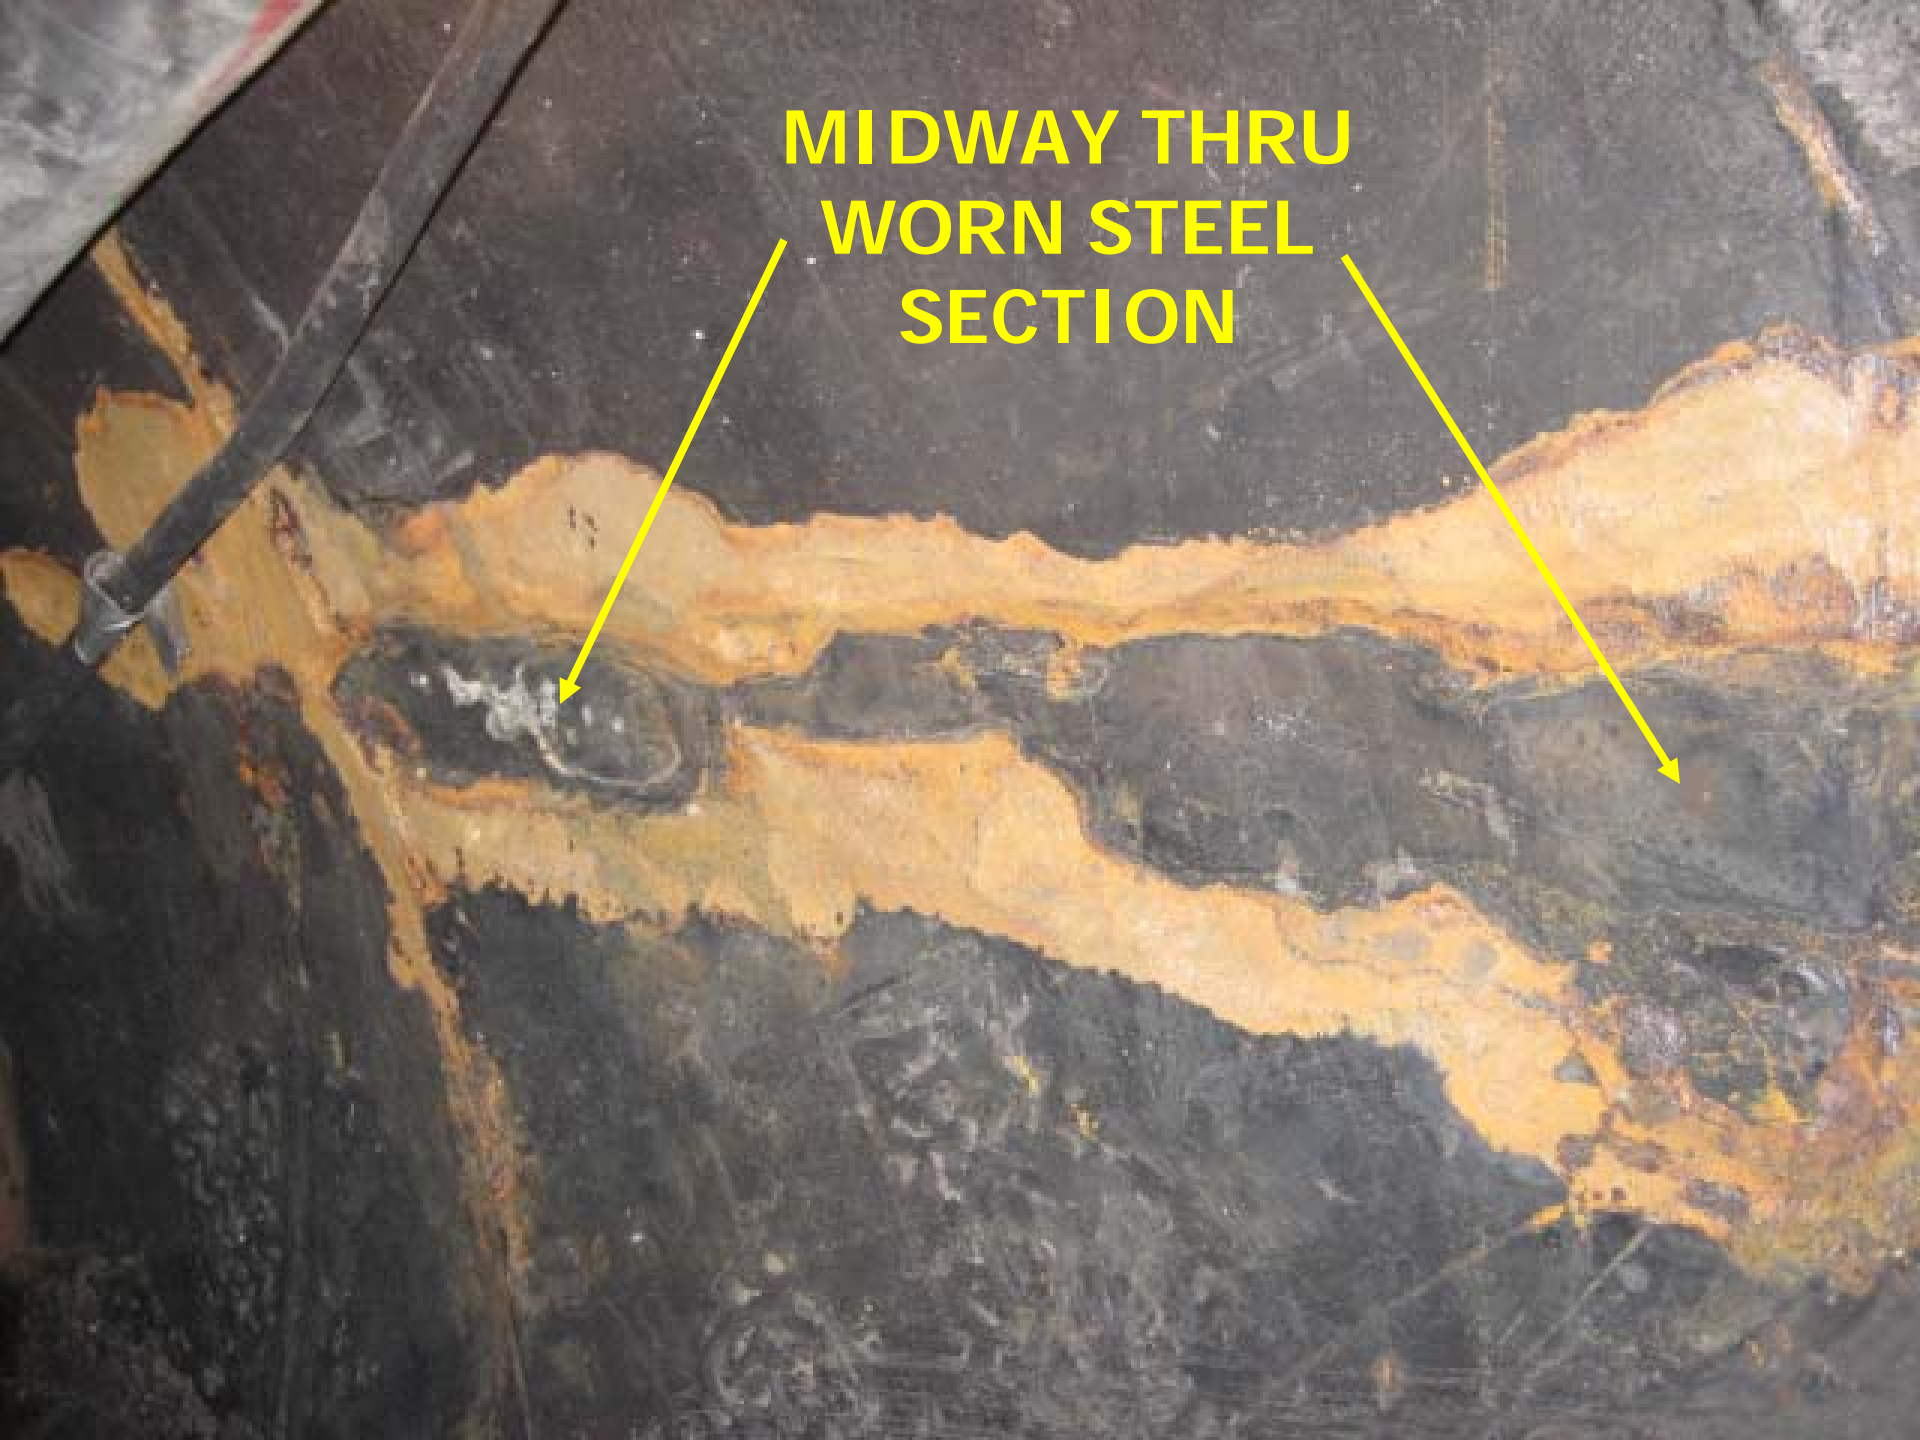
**MIDWAY THRU  
WORN STEEL  
SECTION**
