City and County of Honolulu Large Diameter Pipe Condition Assessment

Presentation Summary

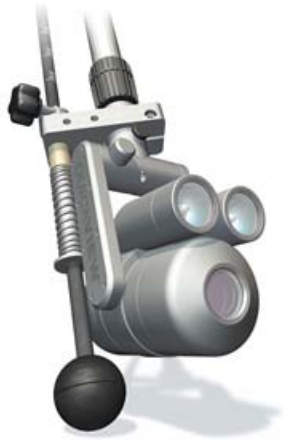
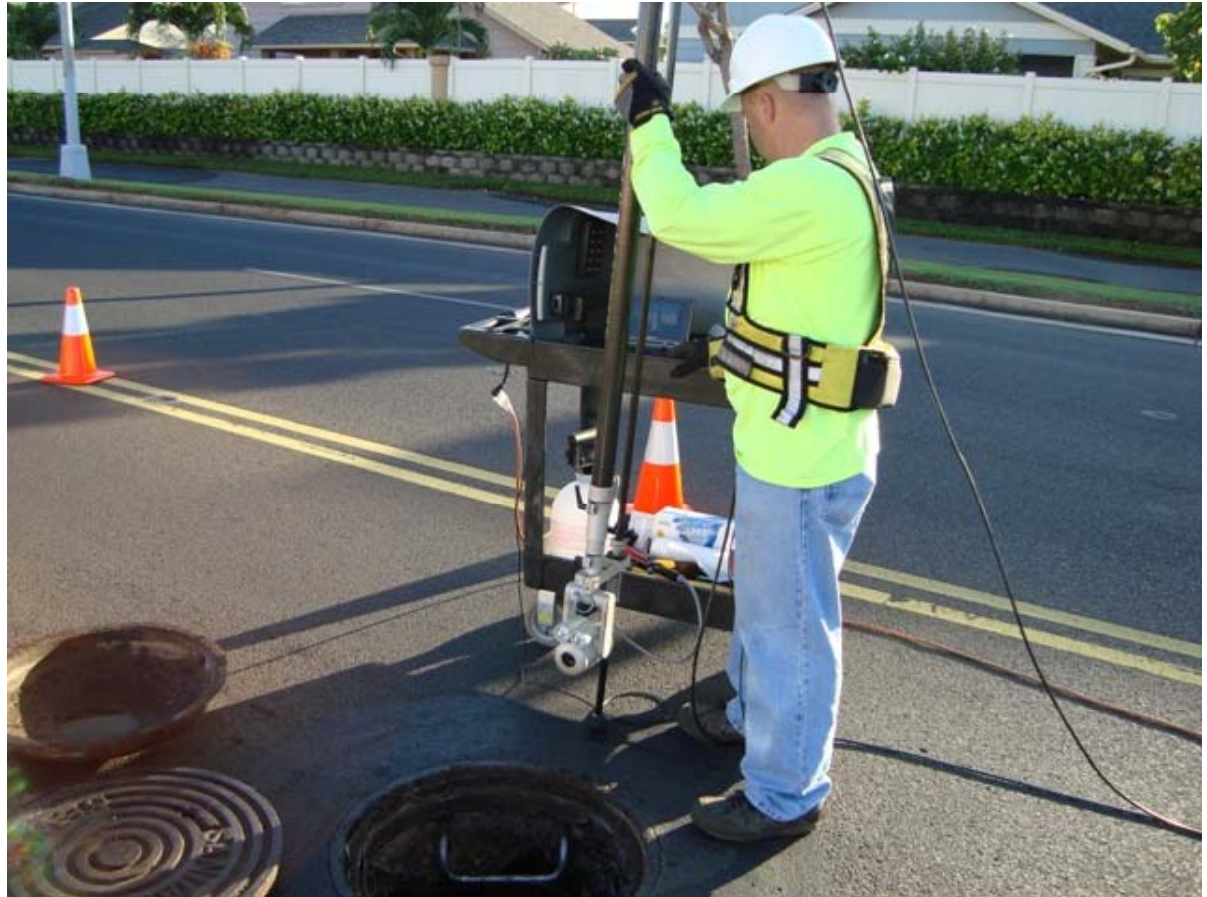
Pole Mounted Digital Video Zoom Camera

- CCTV camera head
- 24 foot carbon fiber pole (6 foot extension)
- Controls on Control Unit

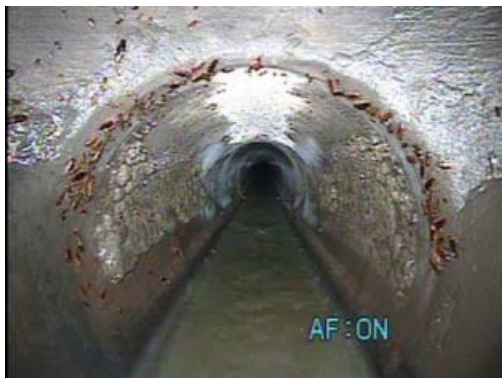
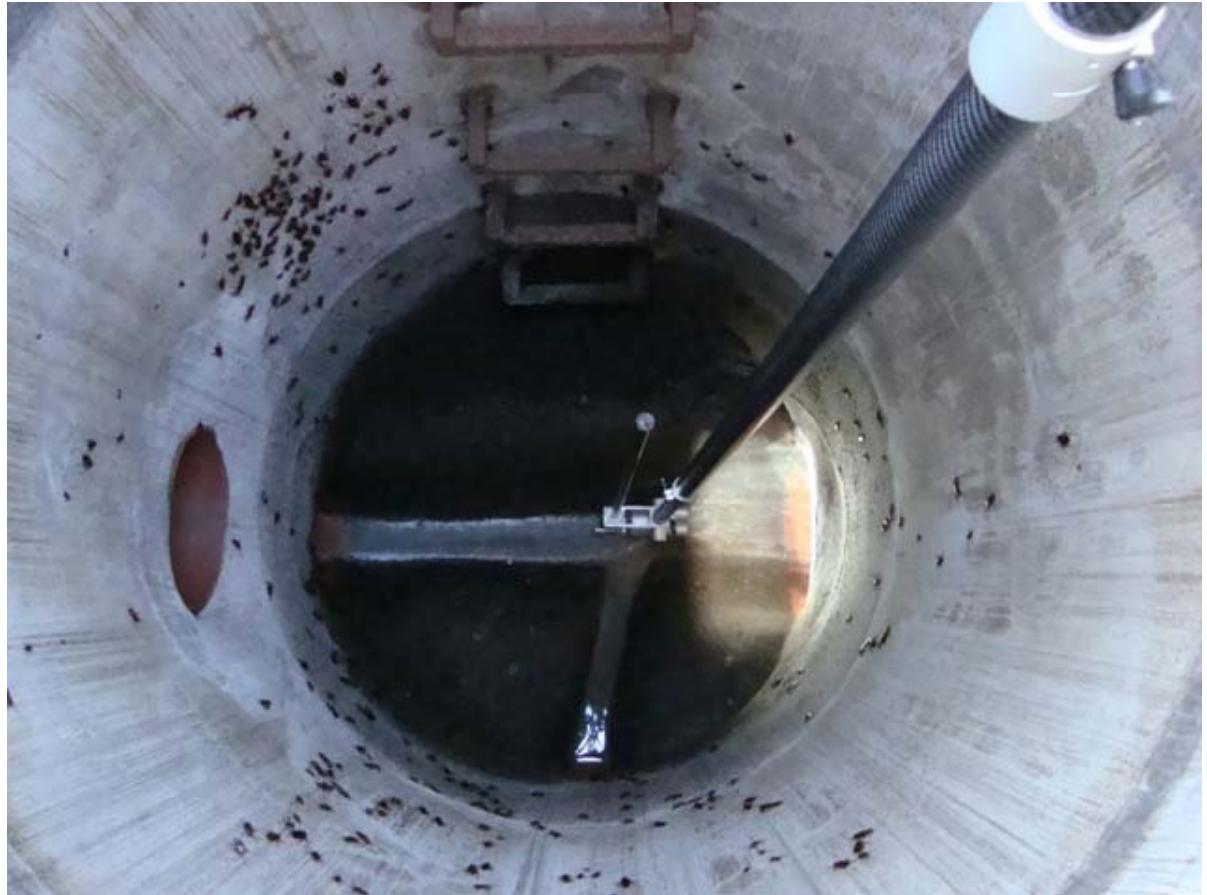
Pole Mounted Digital Video Zoom Camera

- Non-entry inspection for manholes and pipelines
- Screening Tool

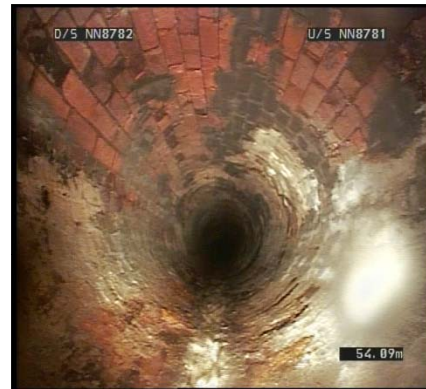
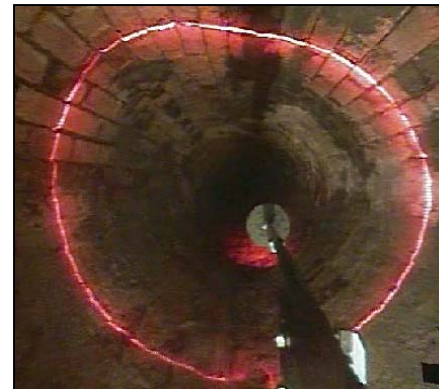
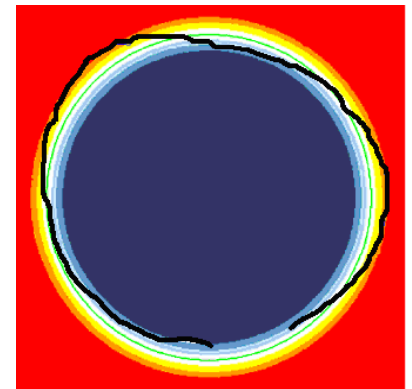
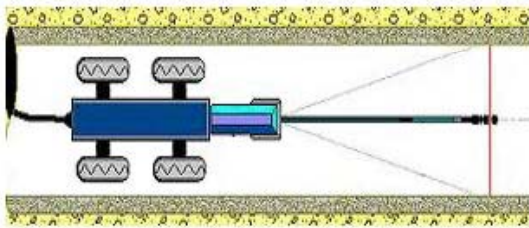
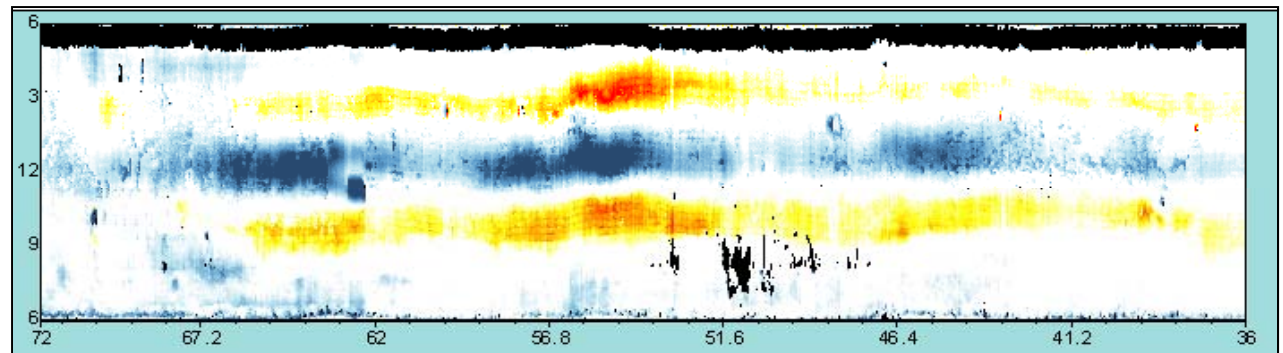
2-D Laser Profiling

- Ring laser
- Combined with CCTV
- Retro-fit to CCTV Camera Screening Tool

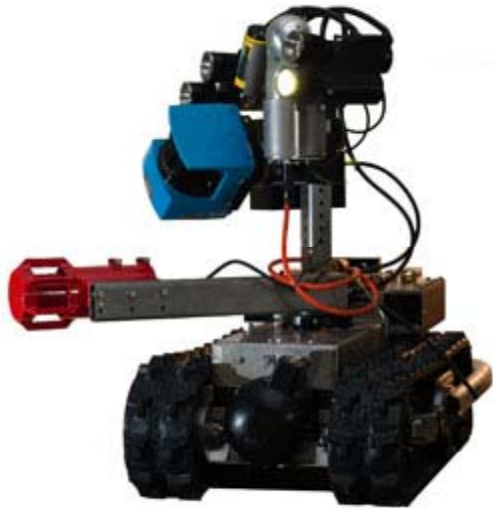
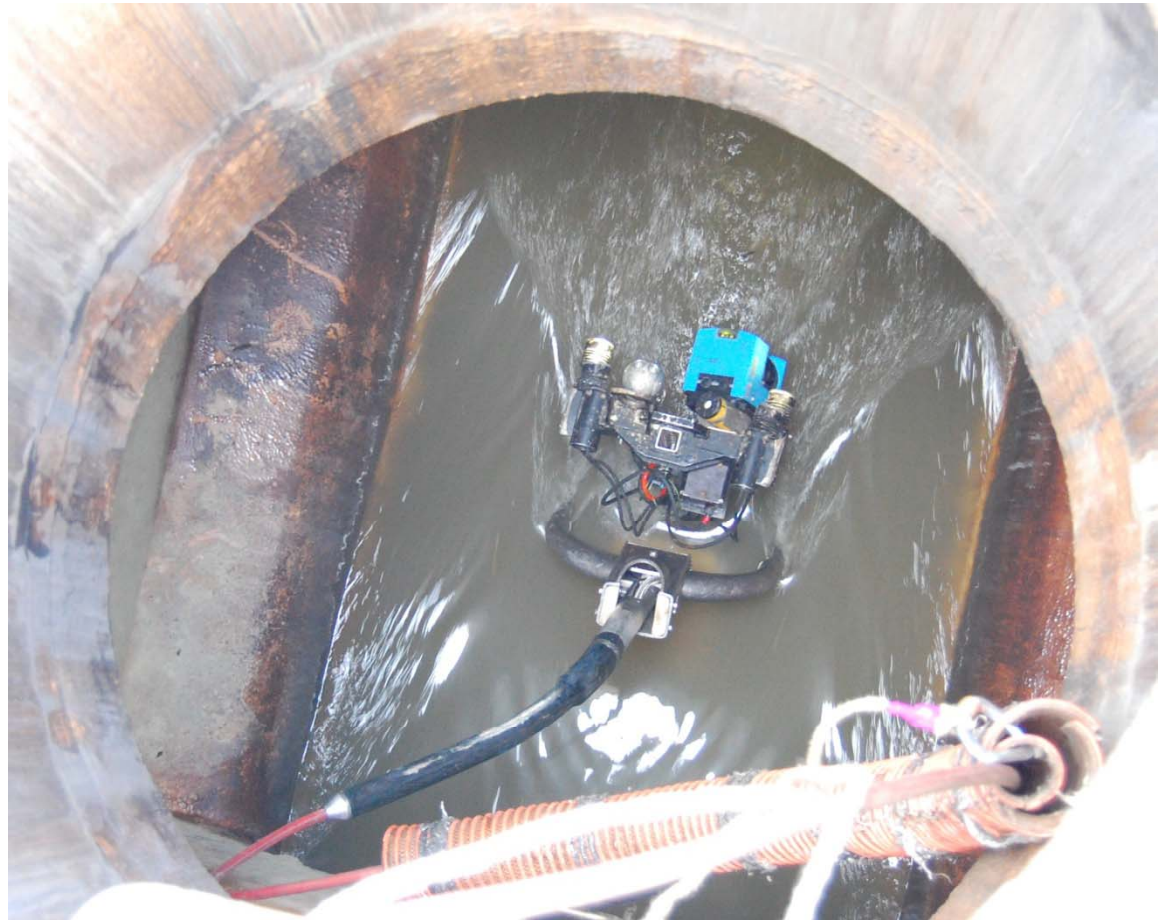
3-D Laser Scanning

- Independent of CCTV Inspection
- 3-D pipeline models
- Minimum 36 inch diameter

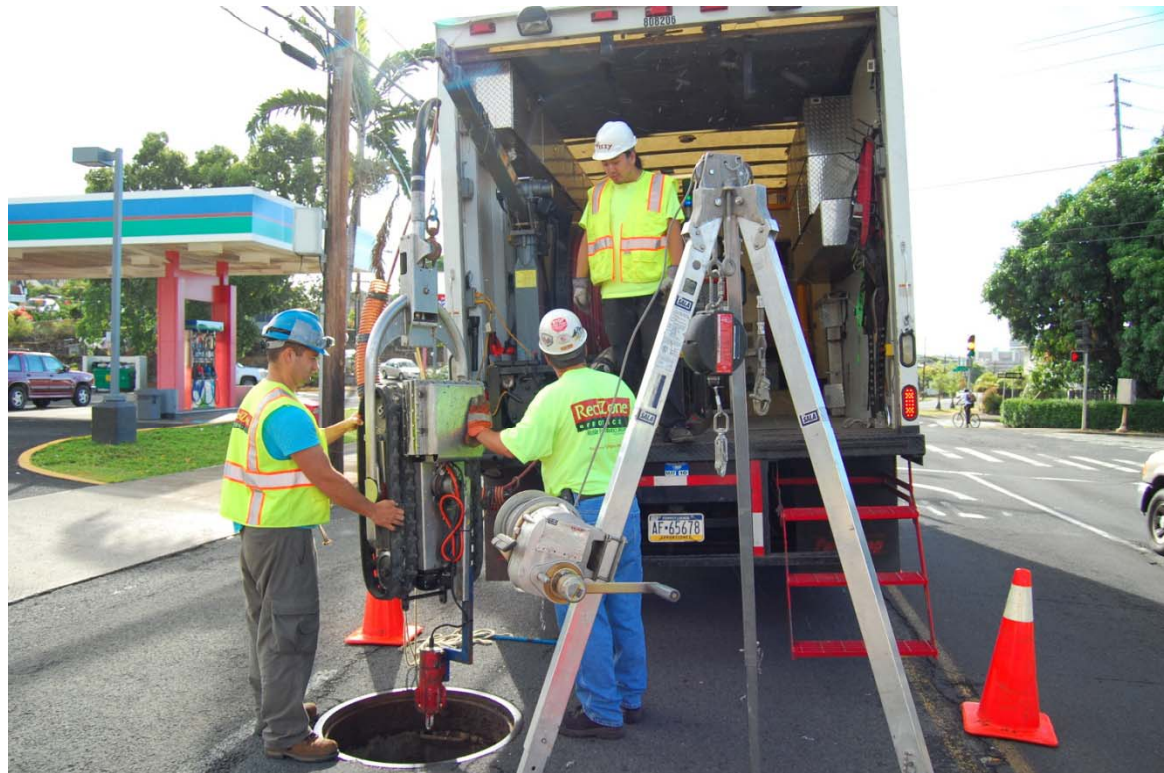
3-D Laser Scanning

- Multi-inspection
 - 3-D laser scanning
 - Sonar profiling
 - CCTV
 - H₂S and temperature measurement
- 650 pounds
- 3.5 hp hydraulic

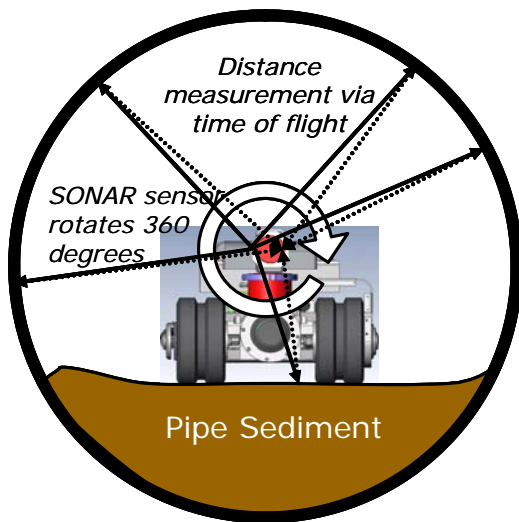
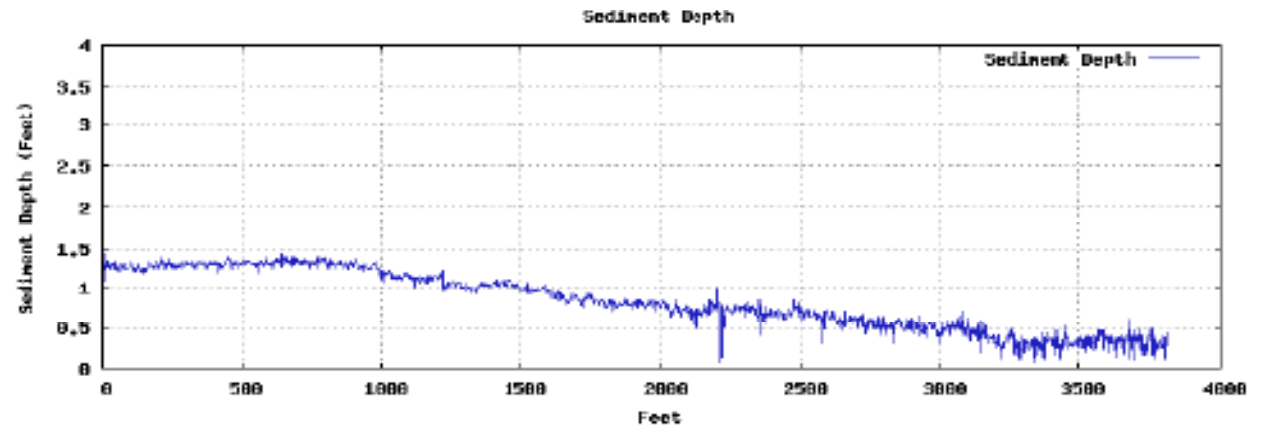
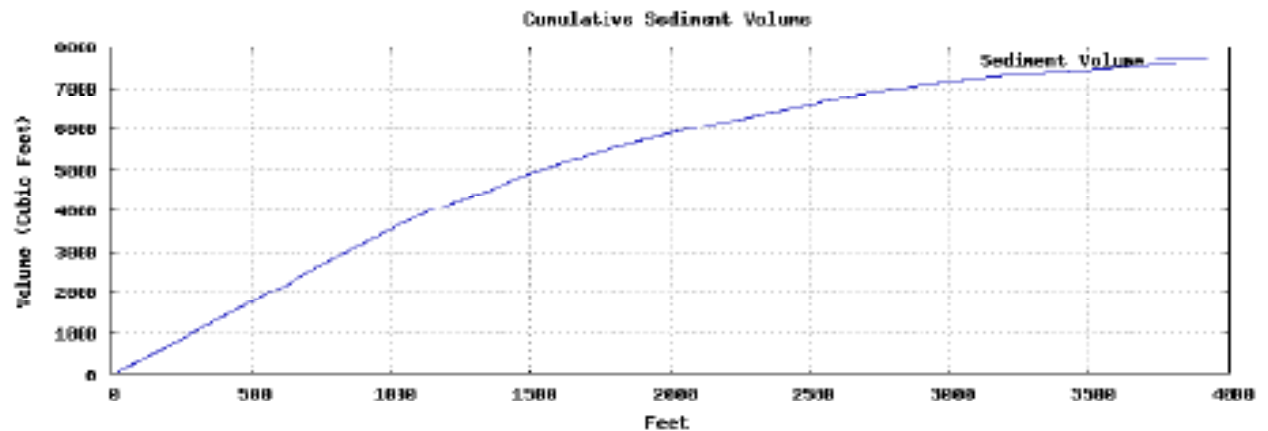
Sonar Profiling

- Inspect below water surface
- Sediment by Footage
- Cumulative Sediment

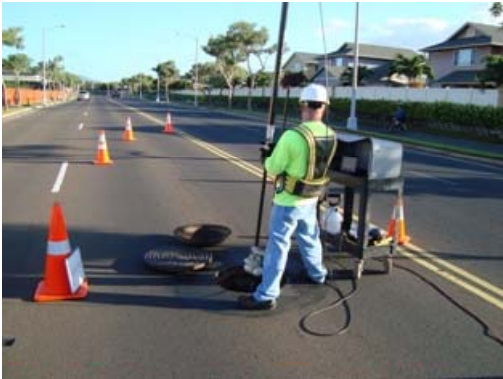
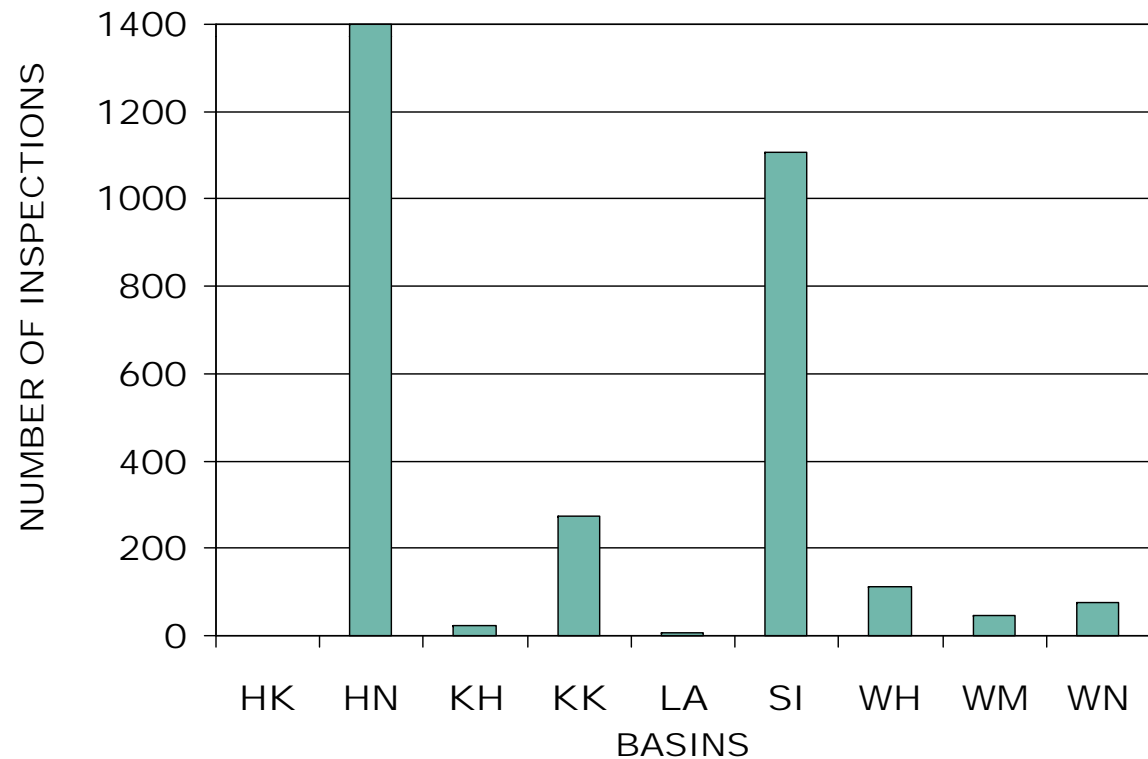
Manhole Inspection Statistics

- 3,000 Non-entry inspections using Pole Zoom Camera
- 100 CSE inspections provided physical information

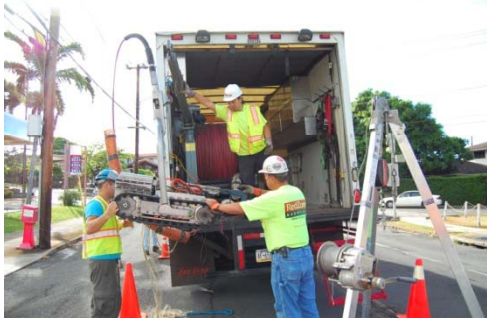
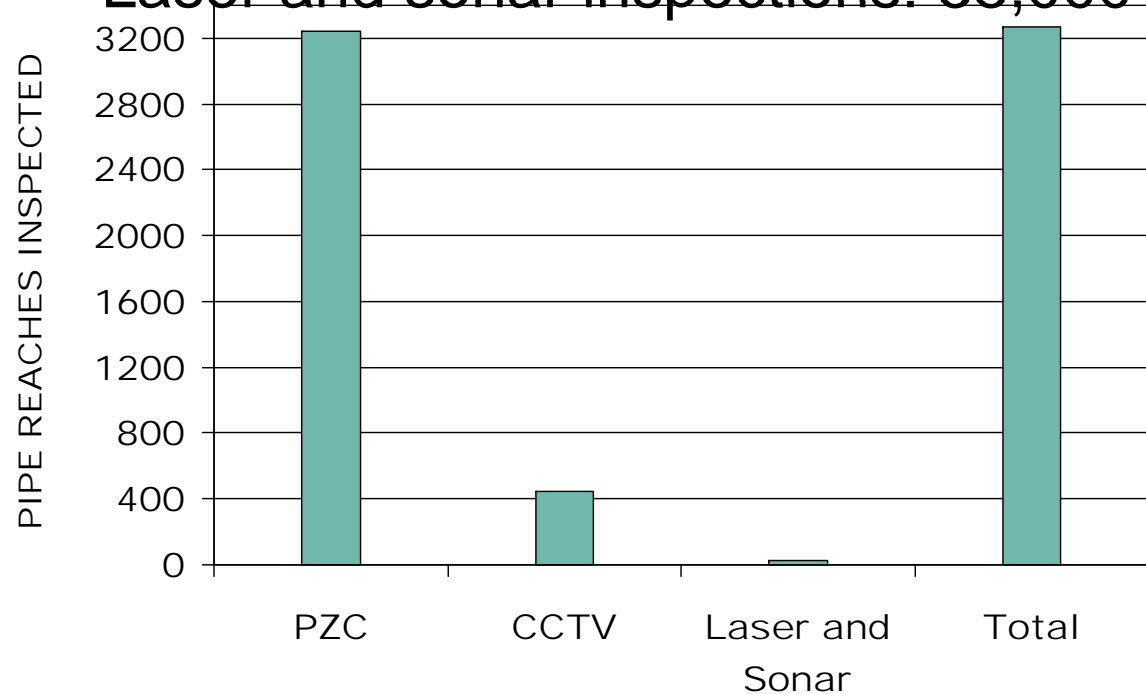
Pipeline Inspection Statistics

- 3,200 Pole zoom camera inspections
 - Approximately 80% of large diameter system
- CCTV inspections: 61,000 LF
- Laser and sonar inspections: 38,000 LF
